# INCIDENT INVESTIGATION REPORT

Type of occurrence <b>Drowning</b>			
Notice of incident number <b>2017112850005</b>	Incident outcome <b>Fatalities (1)</b>	Date of incident <b>January 30, 2017</b>	
Location of incident <b>Tolko sawmill 820 Guy Street Kelowna, B.C.</b>	Primary investigator <b>Martin NICHOLLS</b>	Investigation file number <b>FSI-REG-2017-0012</b>	
Approved by manager, Fatal and Serious Injury Investigations <b>Jeff YOUNG</b>	Signature

At a sawmill, a worker was operating a boom boat (tugboat) in a log storage pond when the boat sank approximately 150 feet from the shore in 10 feet of water. The worker was unable to escape from the submerged boat. The worker drowned.

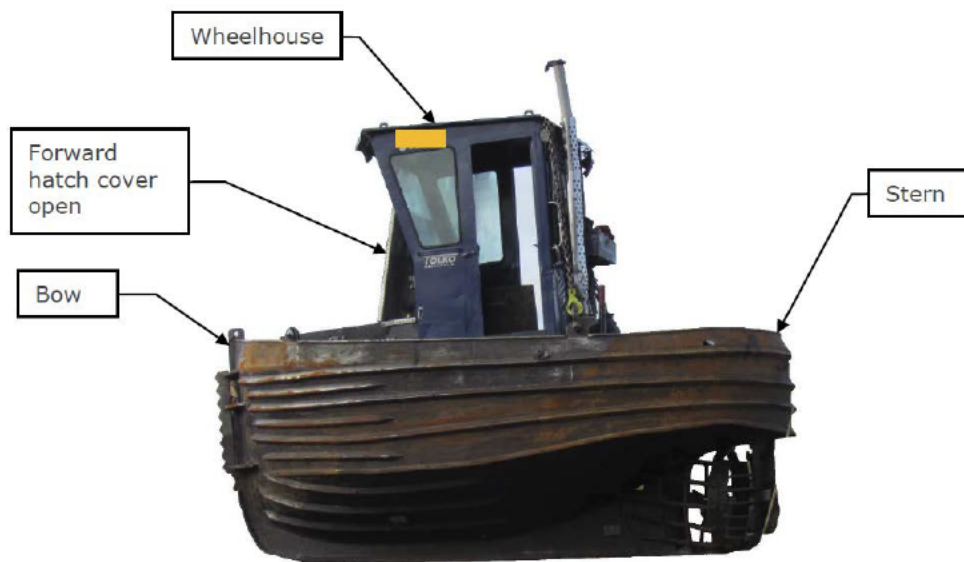
**Figure 1:** The boom boat, showing the wheelhouse and the forward engine hatch cover fully open. (For more information, see section 2.1 of this report.)

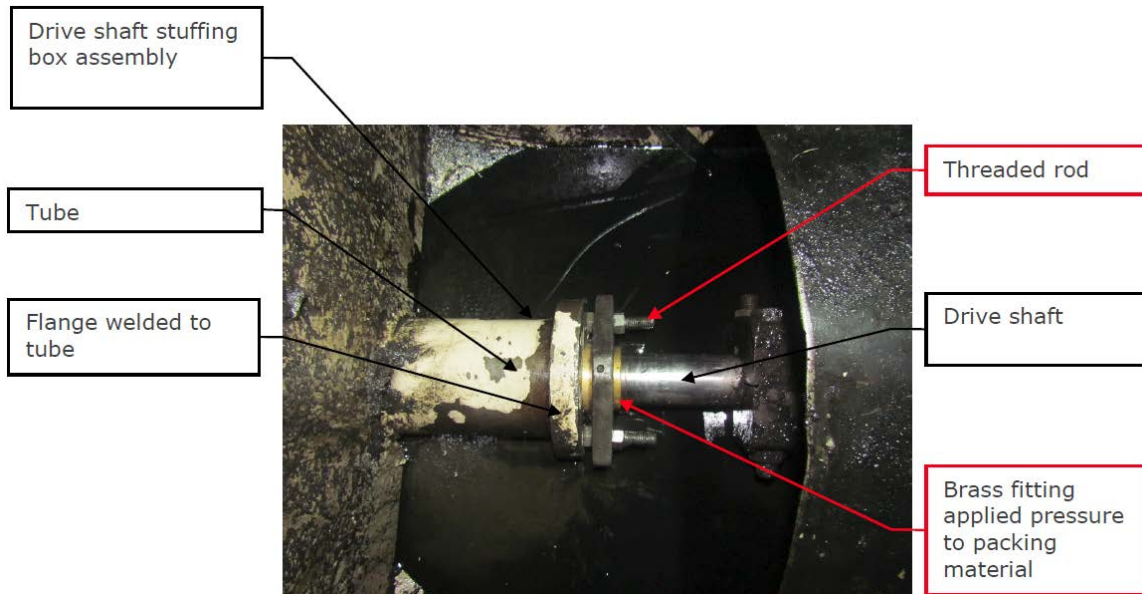
**Figure 3:** Stuffing box on the boom boat, showing nuts fully tightened to the bottom of their range of travel. The red boxes indicate the parts adjusted by the boom boat operators.

Operator 2 completed an operator inspection checklist for the boom boat at the start of his shift at approximately 08:00 hours on the day of the incident and made no comments about the condition of the boat. During his shift, he adjusted the stuffing box and recalled that it was close to the end of its normal adjustment range, indicating that installation of new stuffing would soon be required.

The Loader Operator said that the boom boat could become swamped and sink if the bilge was not pumped out at least once per shift. Operator 2 told investigators that failing to pump out the bilge in a timely manner would result in the boat sinking lower in the water, to the point where water would wash over the front deck of the boat. Boat operators are trained to check the stuffing box seal for excessive leakage every time they pump out the bilge. Operator 2 noticed on the day shift that the stuffing box would need more packing added soon. Operator 1 also noted on the boat inspection sheet he completed that the stuffing box adjustment was at the bottom of its range of adjustment.

The stuffing box was inspected and found to be allowing a small amount of water to enter the boat. The amount of leakage was not significant and was considered normal. If Operator 1 did in fact pump out the bilge prior to the incident, the leakage at the stuffing box is not considered a factor in the sinking.

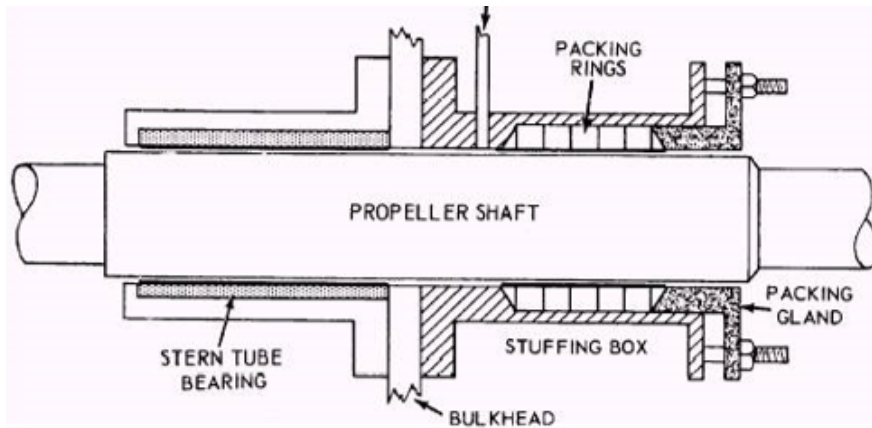
**Figure 4:** Diagram of a similar stuffing box, showing the adjustable packing gland that requires periodic tightening on the boom boat using the adjustment nuts. (Source: Integrated Publishing website, [tpub.com/engine1/en1-85](http://tpub.com/engine1/en1-85))

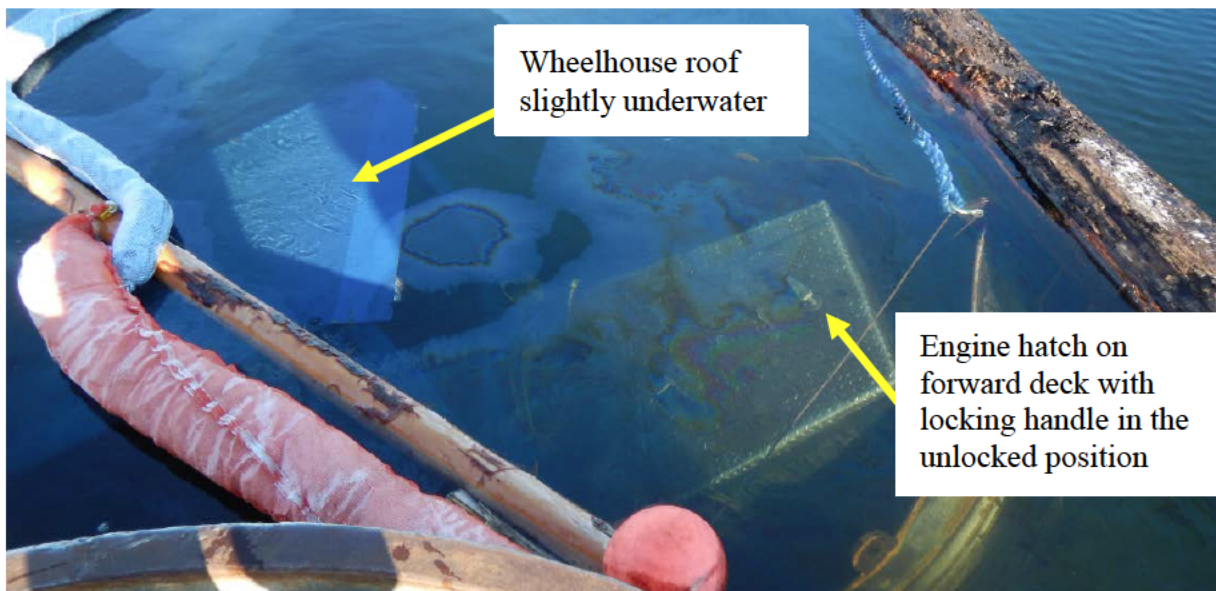
The boom boat sank in approximately 10 feet of water about 150 feet from the nearest shore, close to a dolphin. The wheelhouse was only a few inches under the surface of the water. The door on the left side (port side) of the boat was open and in a latched position against the rear bulkhead of the wheelhouse. The engine cover on the front deck of the boat was in place, but the locking latch for the hatch was in the open position. In other words, the engine cover was not locked (see Figure 5).

**Figure 5:** The boom boat resting on the bottom of the pond, just slightly under the surface of the water. The engine hatch cover latch (locking handle) is in the open (unlocked) position.

As mentioned above, when the boat was recovered, the engine hatch was not locked closed.

With the front of the boat underwater, water was able to enter through the unsecured engine hatch, resulting in the boat becoming swamped and sinking.

The exact circumstances surrounding the sinking of this boat are unknown because the incident was not witnessed. However, given the information that is available and the nature of this work, it is logical to conclude that the boat was swamped by water that rapidly filled the engine compartment, causing the boat to sink quickly. The boom boat's engine hatch was not closed properly. It was supposed to be secured by turning a handle that was found in the open position after the incident. This open hatch would allow large volumes of water into the engine compartment of the boat if it was swamped. Given the nature of this work, swamping could occur if the front of the boat was driven underwater as a result of a collision with an object (such as a bundle of logs) or from pushing a bundle of logs.

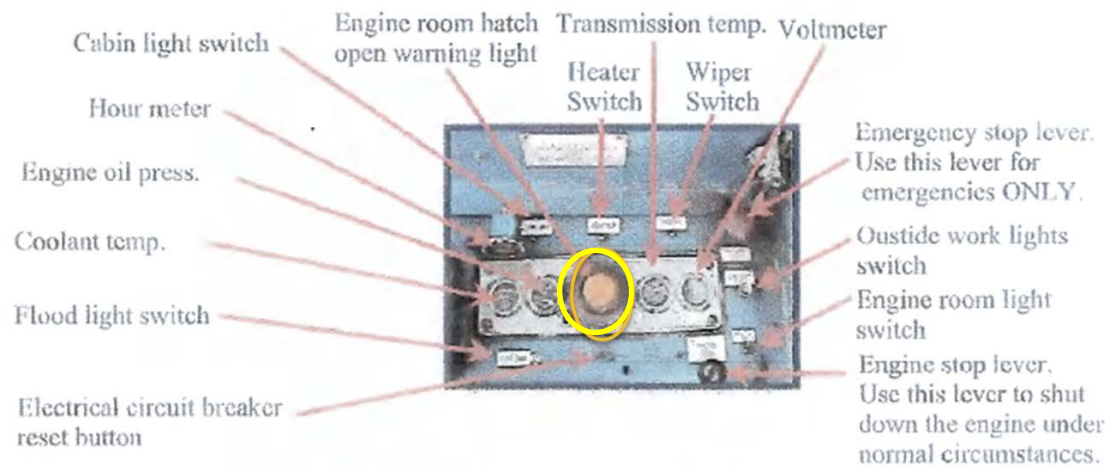
The training manual for the boat includes a labelled photograph that depicts a warning light to warn if the front hatch was not locked. (See Figure 6.) Examination of the boom boat revealed that the dashboard and controls on the boom boat were significantly different from the image in the training manual. No warning light for the engine hatch cover was noted on the existing dashboard. The boom boat was rebuilt in 2012 and received a new wheelhouse and dashboard at that time. The designer of the boat as it was originally configured may have considered an unlatched hatch to be a hazard to operation of the boat; hence, the warning light on the control panel.

**Figure 6:** Image from the safety competency training manual for the boom boat, showing the boom boat controls, including a large red warning light labelled “Engine room hatch open warning light.” (Source: Tolko Industries Ltd)

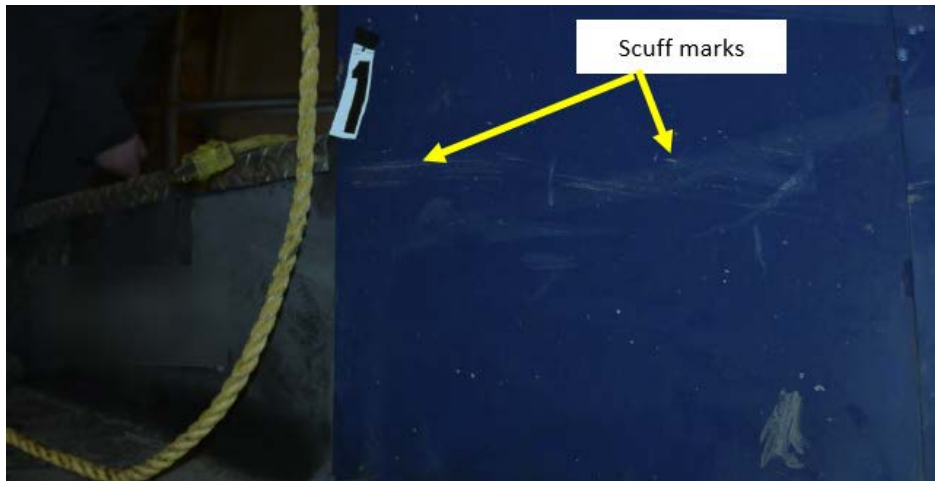
The wheelhouse of the boom boat was painted blue. Close examination of photographs taken by the RCMP Marine Investigation Team revealed blue paint transfer to a bundle of logs stored in the pond. Scuff marks with wood fibres adhered to them were observed on the left side of the wheelhouse and in the RCMP investigator’s opinion may have been the source of the paint transfer to the logs. (See Figure 7.) It is possible that the scuff marks resulted from contact with this bundle of logs. These scuff marks were at the same height as the front hatch on the boom boat, which may explain how the unfastened hatch came to be open, allowing water to enter and sink the boat.

*Figure 7: Scuff marks that are the possible source of paint transfer to a bundle of logs observed after the incident. (Source: RCMP)*

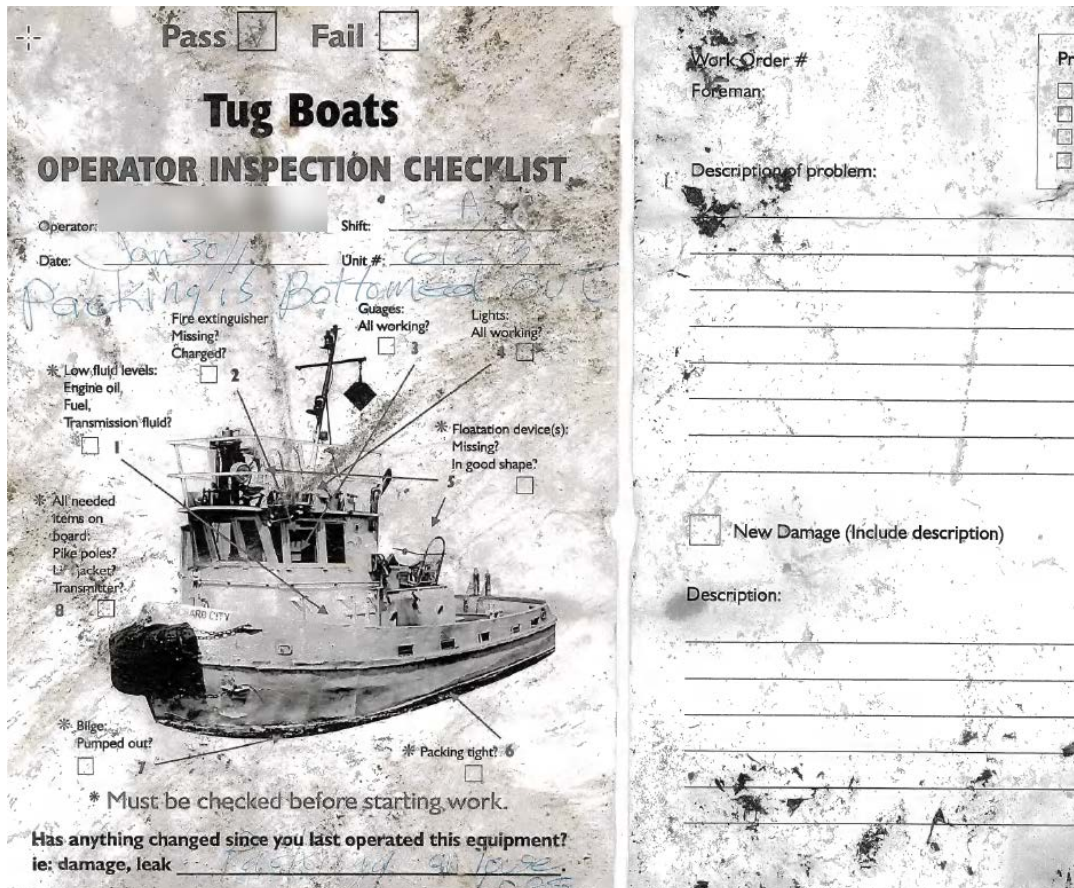
Operator 1 worked in the mill pond operating the boom boat and completed an operator inspection checklist sometime after arriving for his shift. On the checklist, he indicated that the boom boat passed the inspection and noted: “Packing is bottomed out.” Where the checklist asked, “Has anything changed since you last operated this equipment? ie: damage, leak,” Operator 1 noted: “Packing all loose — loss.” The precise meaning of this comment is unclear, but it does refer to a change in the packing since Operator 1 had last operated the boom boat.

Section 1.4.1 above describes the checklist and inspection protocol used by the boat operators on the day of the incident. Figure 8 shows a copy of the checklist prepared by Operator 1, presumably when his shift commenced on the day of the incident. There is no specific reference to ensuring the front hatch is locked. None of the checkboxes were checked off by Operator 1. Only a brief note describing the condition of the packing material in the stuffing box was recorded on the inspection checklist.

Figure 8: Operator inspection checklist filled out by Operator 1 on the day of the incident.

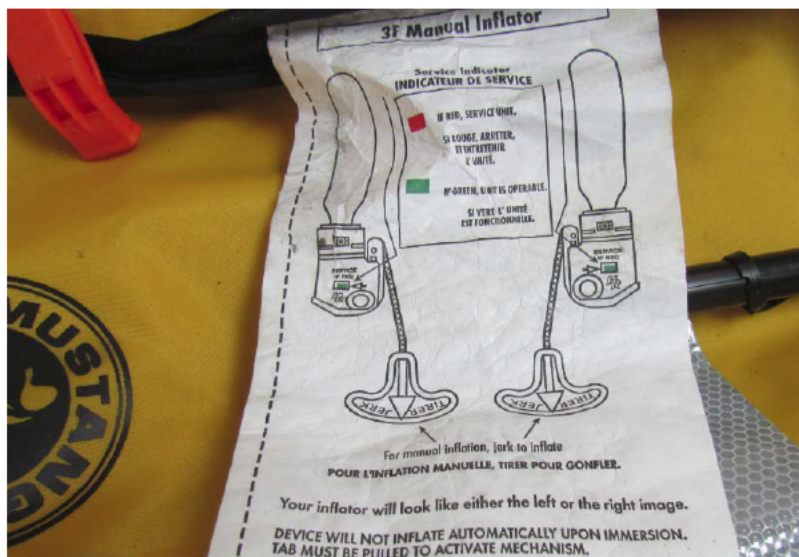
**Figure 9:** Close-up of a tag found inside the PFD, showing how the handle hangs out the bottom of the PFD and is jerked to inflate the buoyancy aid.

mechanism was inspected, and it was discovered that the pull cord was improperly routed so that no amount of force would result in deployment. The PFD appeared to have either been re-armed or manufactured improperly and was non-functional. This could have been due to improper repacking by users of the PFD or a design and manufacturing issue.

The PFD worn by Operator 1 was neither inherently buoyant nor automatically inflatable and therefore did not meet the requirements of any subsections of section 8.27 of the Regulation. The PFD worn by Operator 1 and by other persons operating the boom boat did not comply with the Regulation.

In addition, the PFD was inspected after the incident and found to be non-functional. The pull cord that activates the inflation mechanism was improperly routed, rendering the PFD inoperative. This could have been due to improper repacking by users of the PFD or a design and manufacturing issue.

- Inspected all PFDs at the workplace and replaced all manually operated PFDs with PFDs that automatically inflate.
- All workers are required to report to the control room staff at the start of their shift.
- Shift supervisors are to have personal contact with boat operators at least once per shift.
